Application
Resistance Welding

Products Used
955S

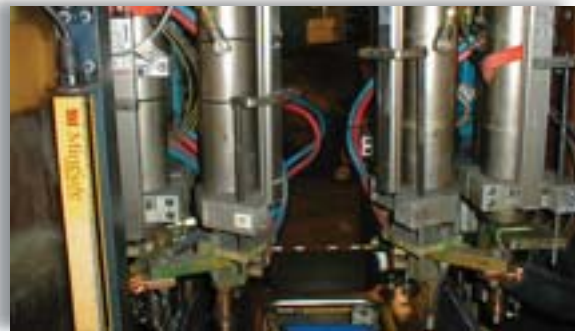
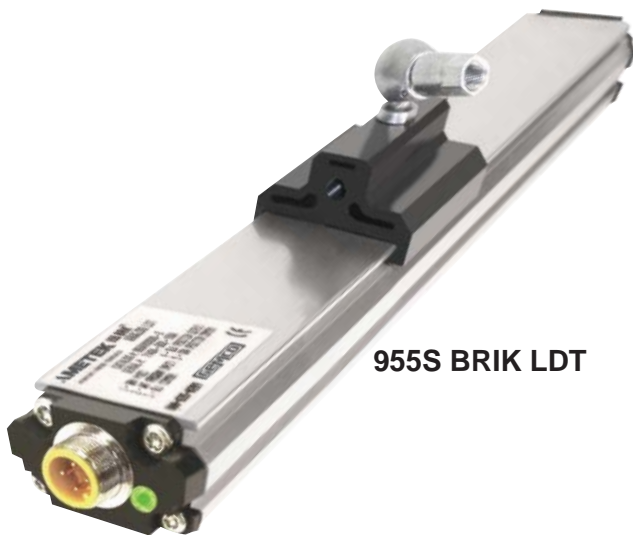
955S BRIK LDT

The customer attached a 955S LDT & Floating Magnet on each weld head. As the weld heads approach the nuts, position readings are taken. The nuts have weld projections on the backside of the nut. If one or more of the nuts are upside down, the weld projections cause the position readings to be different than when the nuts are in the proper position. This 'bad position' information is sent to the PLC and the welding operation is halted.

Attaching the LDT to each weld head enables contact with the nut and ensures that it is properly seated. By doing this, the possibility of scrapping material is lessened.
